**SITE INSPECTION REPORT
NIAGARA FALLS BOULEVARD
9524 AND 9540 NIAGARA FALLS BOULEVARD
NIAGARA FALLS, NEW YORK**

CERCLIS ID No.: NYN000206699

June 2014

Weston Solutions, Inc.
Edison, New Jersey 08837

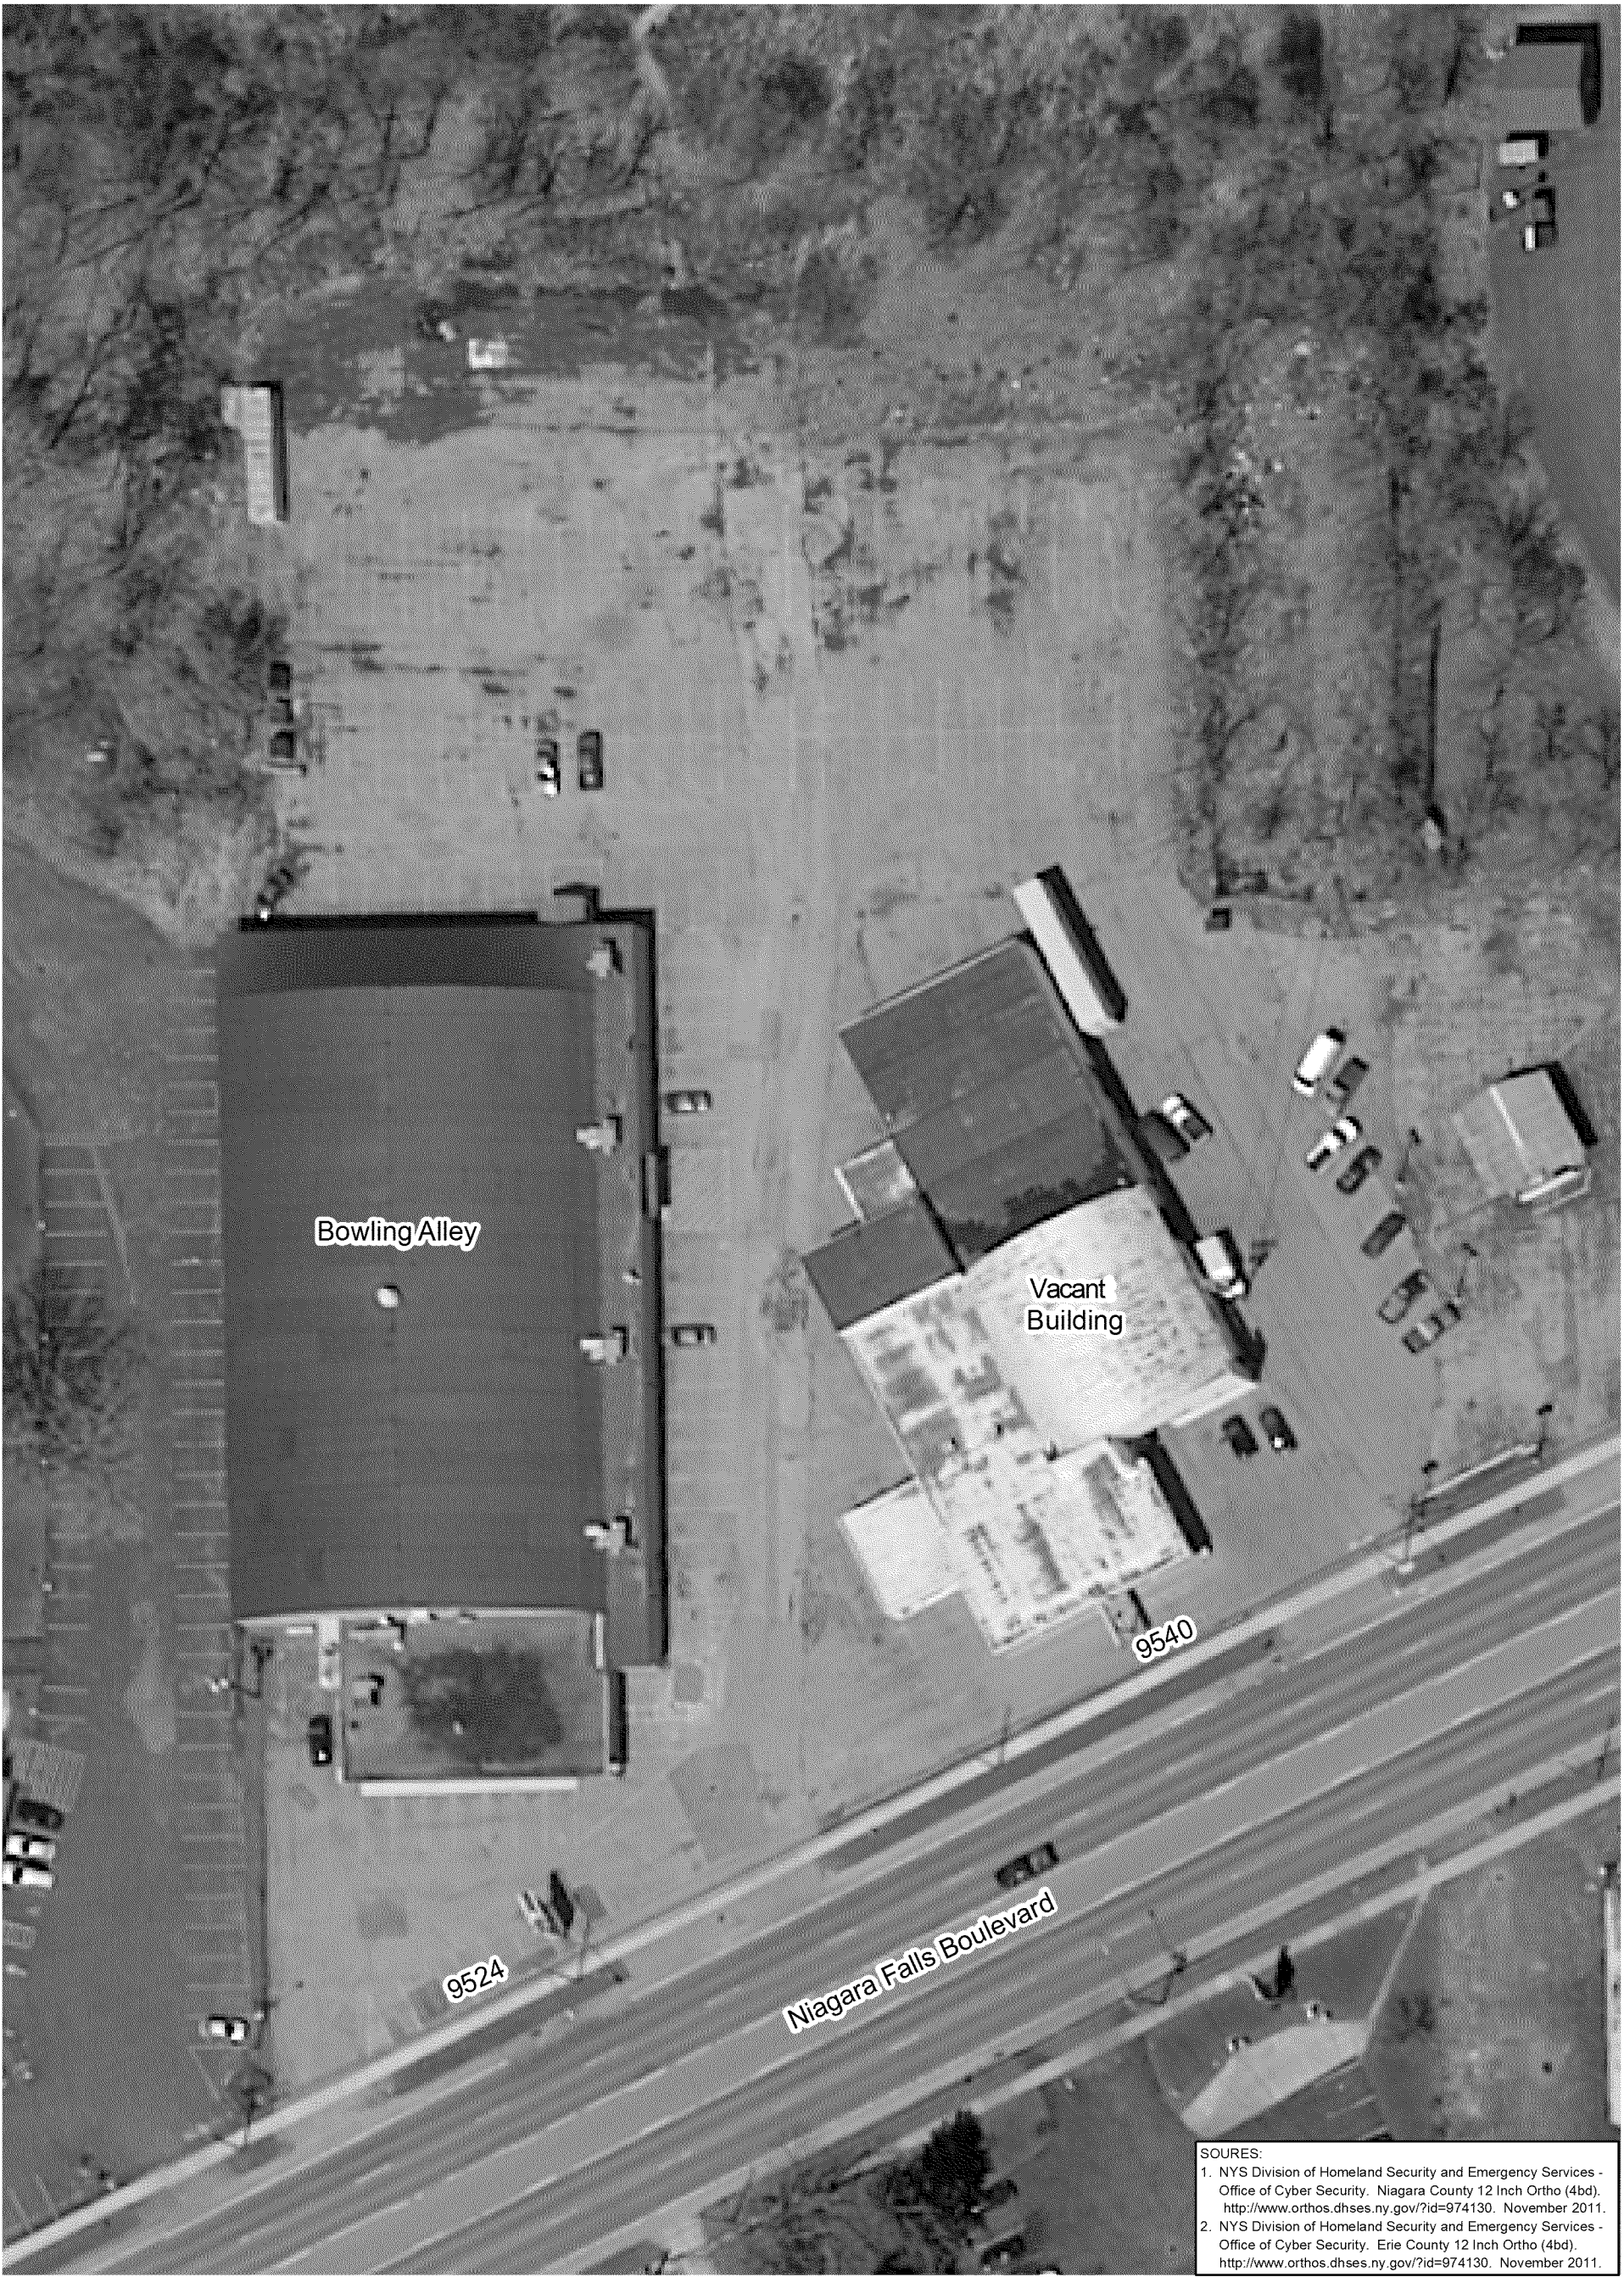
DRAWING NUMBER: 14338	FIGURE #: 2

TITLE: <div>Site Map Niagara Falls Boulevard Niagara Falls, NY</div>

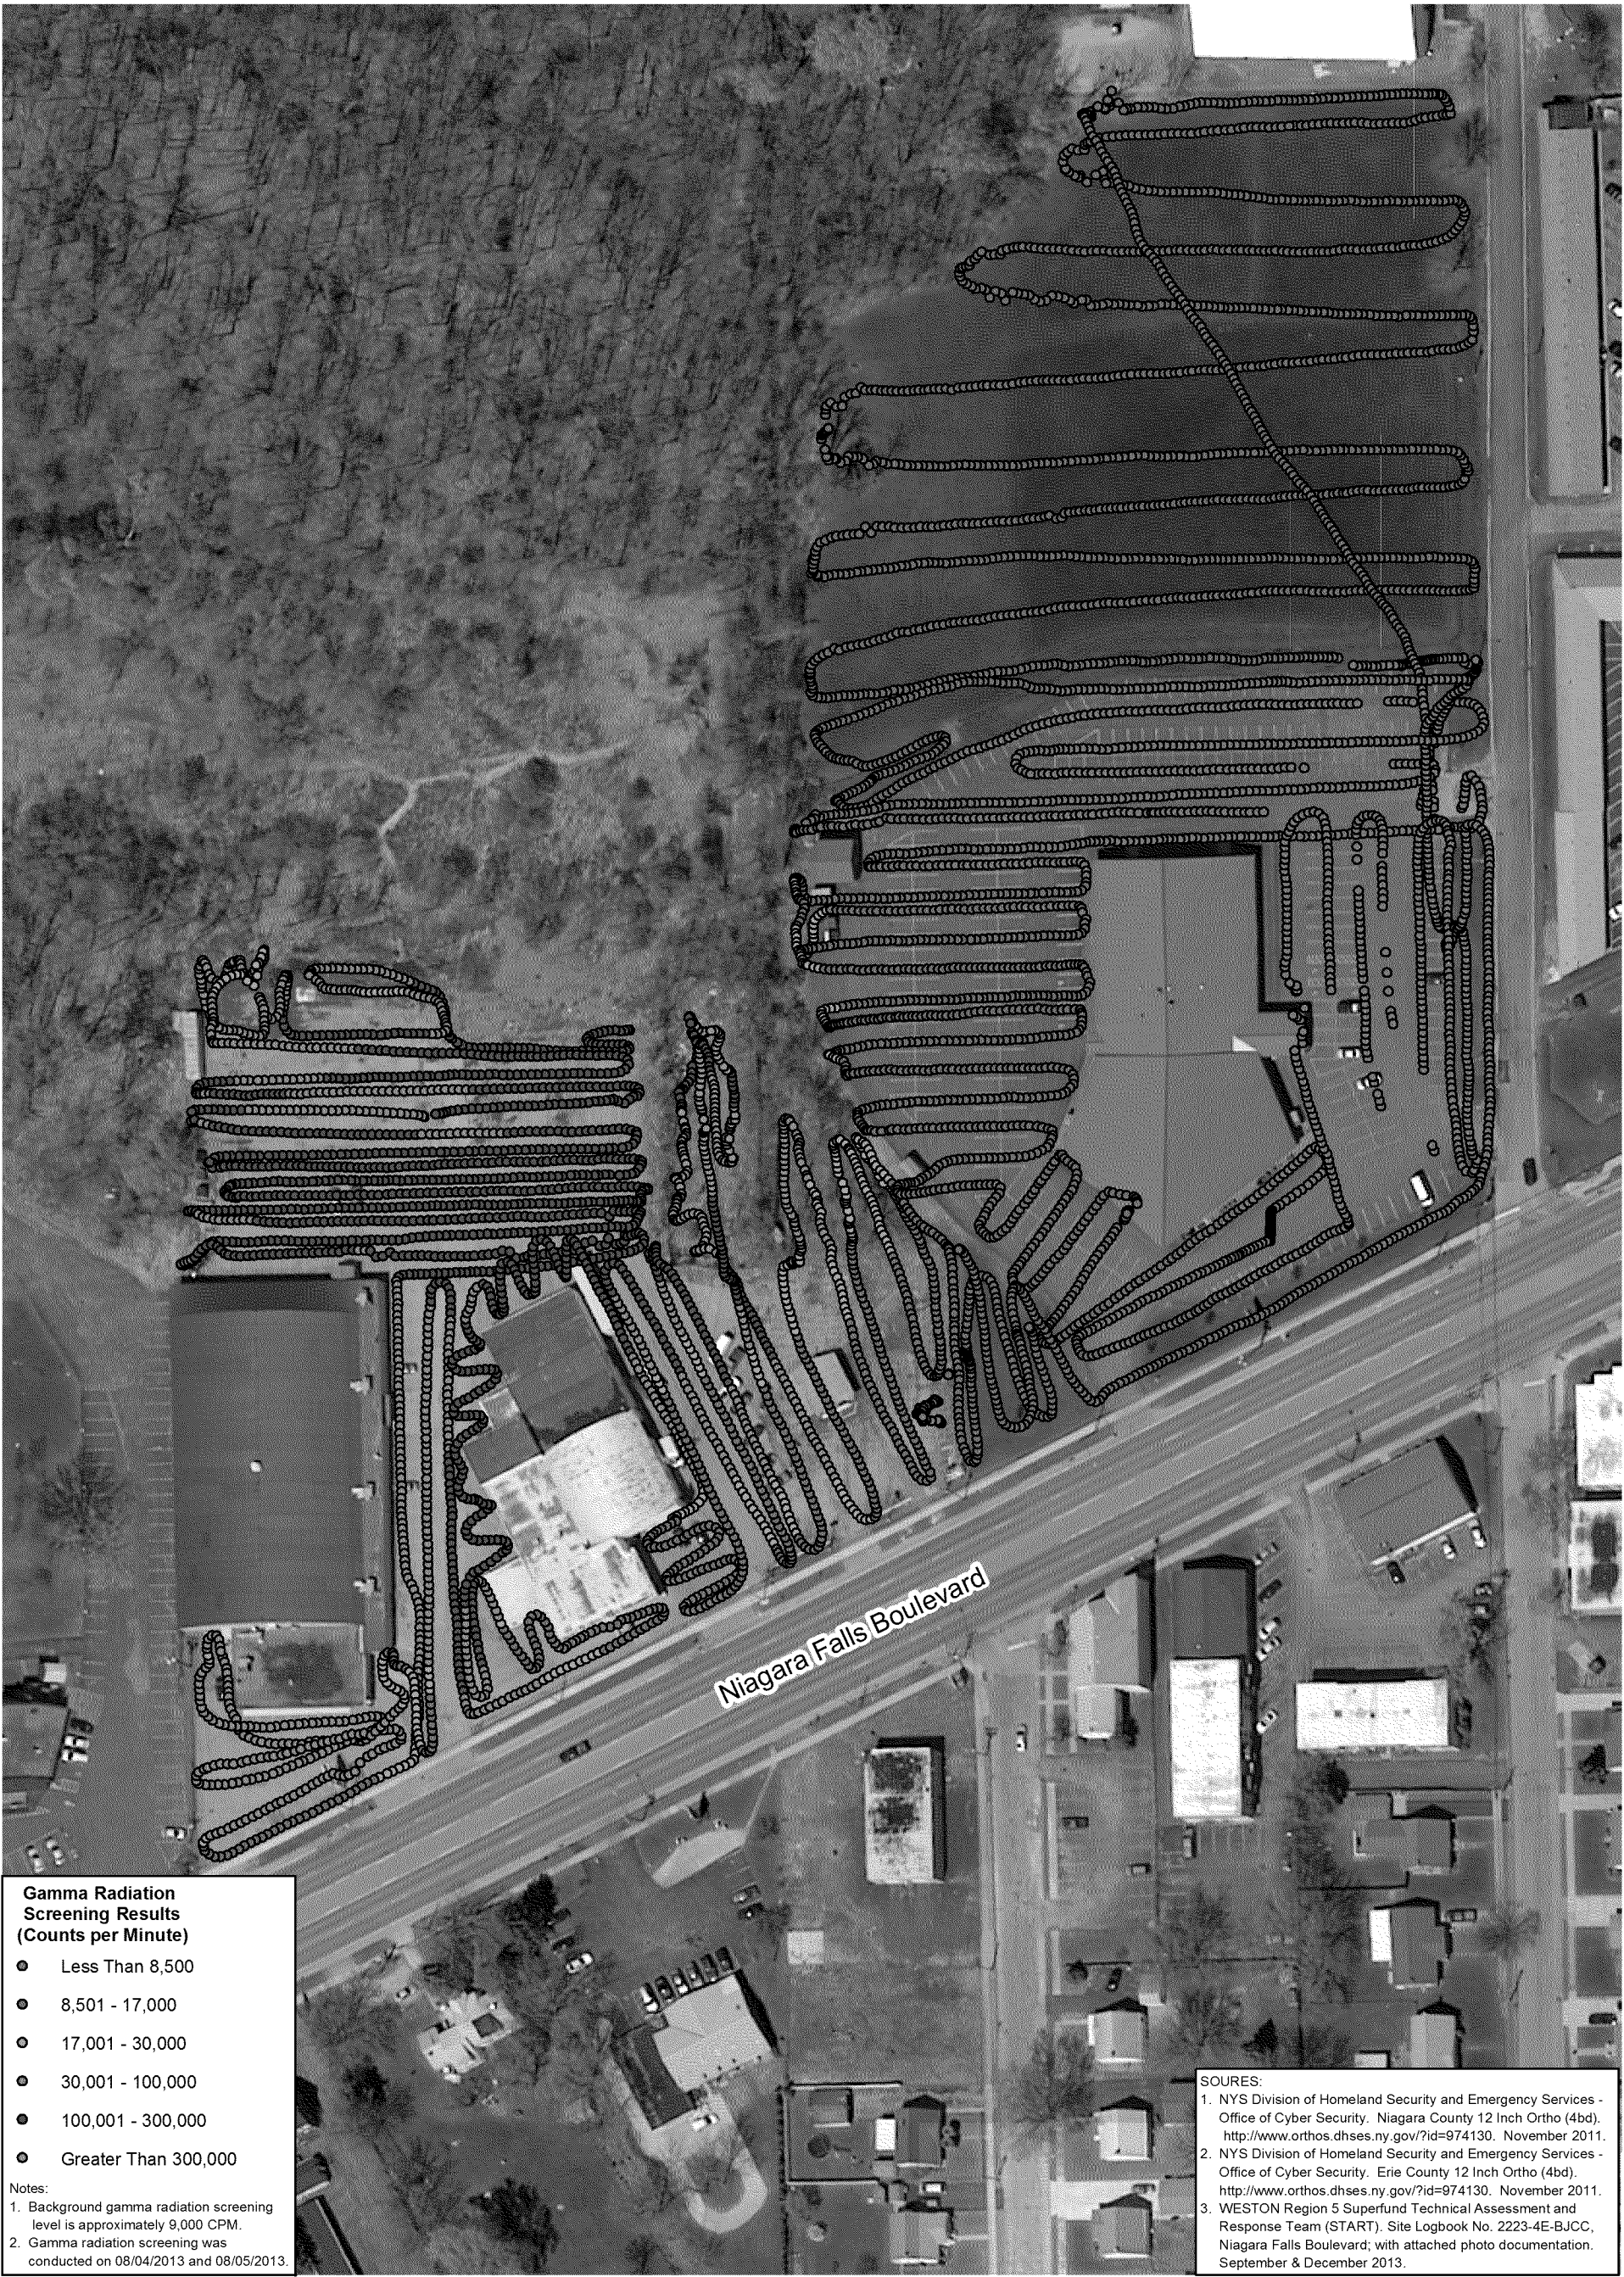
FIGURE #:
3

Gamma Radiation Screening Results (Counts per Minute)

- Less Than 8,500
- 8,501 - 17,000
- 17,001 - 30,000
- 30,001 - 100,000
- 100,001 - 300,000
- Greater Than 300,000

Notes:
1. Background gamma radiation screening level is approximately 9,000 CPM.
2. Gamma radiation screening was conducted on 08/04/2013 and 08/05/2013.

TITLE:
Gamma Radiation Screening Results Map
12/04/2013 and 12/05/2013
Niagara Falls Boulevard
Niagara Falls, NY

On September 10, 2013, Weston Solutions, Inc. (WESTON[®]) conducted a gamma radiation screening of the 9524 Niagara Falls Boulevard property using a Ludlum 2221 Scaler Ratemeter [Ref. 7, pp. 3– 5, 17]. On December 4– 5, 2013, further radiological survey information was obtained from the 9524 and 9540 Niagara Falls Boulevard properties, as well as the church property located further east of the two site parcels [Ref. 7, pp. 6– 8]. The highest gamma radiation screening results were recorded from the exposed soil area of the rear, northern portion of the 9540 Niagara Falls Boulevard property [Ref. 7 p. 12]. A Gamma Radiation Screening Results Map, which depicts the levels of gamma radiation detected at 1 meter above ground surface during the December survey, is included as Figure 3 in this report.
